REPLACEMENT RESERVE REPORT FY 2020 EAGLE'S POINTE POA

REPLACEMENT RESERVE REPORT

EAGLE'S POINTE POA

BLUFFTON, SOUTH CAROLINA

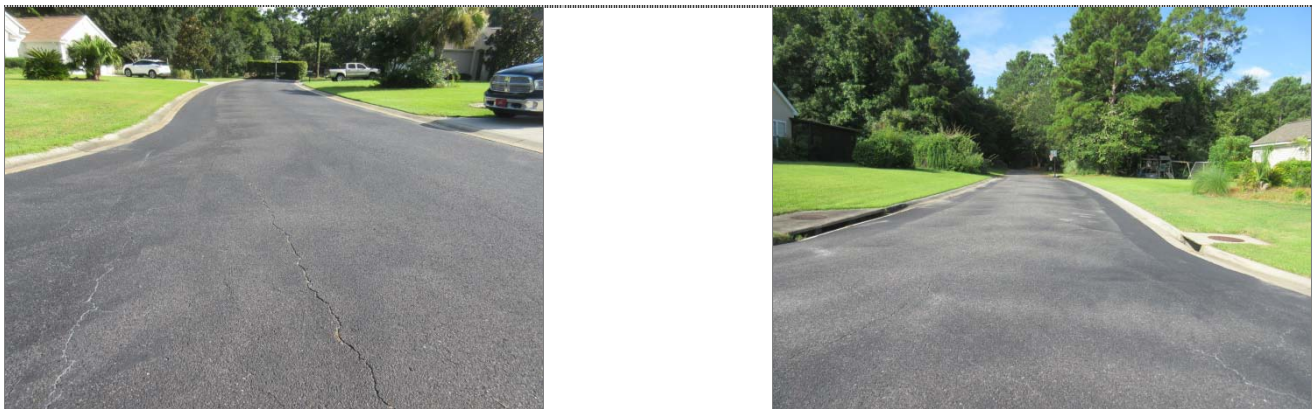
Asphalt Pavement. The Association is responsible for some of the roadways and parking areas within the community; other roadways are maintained Golf Club Association. In general, the Association's asphalt pavements are in fair condition, with minor cracking. We were informed that the streets were all re-sealed in 2017.

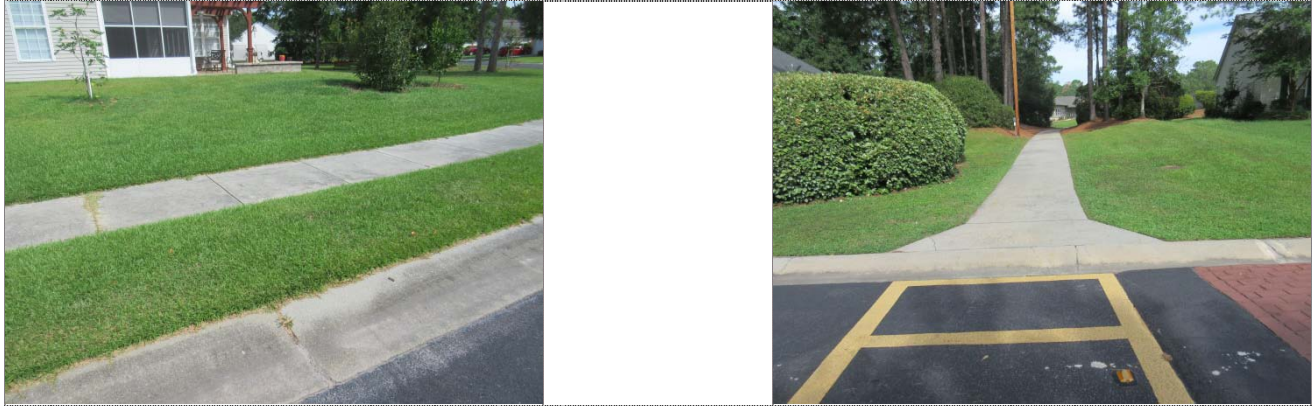
Concrete Work. The concrete work includes the community curbs, sidewalks, and other flatwork. We have modeled for curb replacement when the asphalt pavement is overlaid. The overall condition of the concrete work is good.

- Trip hazard, ½ inch height difference.
- Severe cracking.
- Severe spalling and scale.
- Uneven riser heights on steps.
- Steps with risers in excess of 8¼ inches.

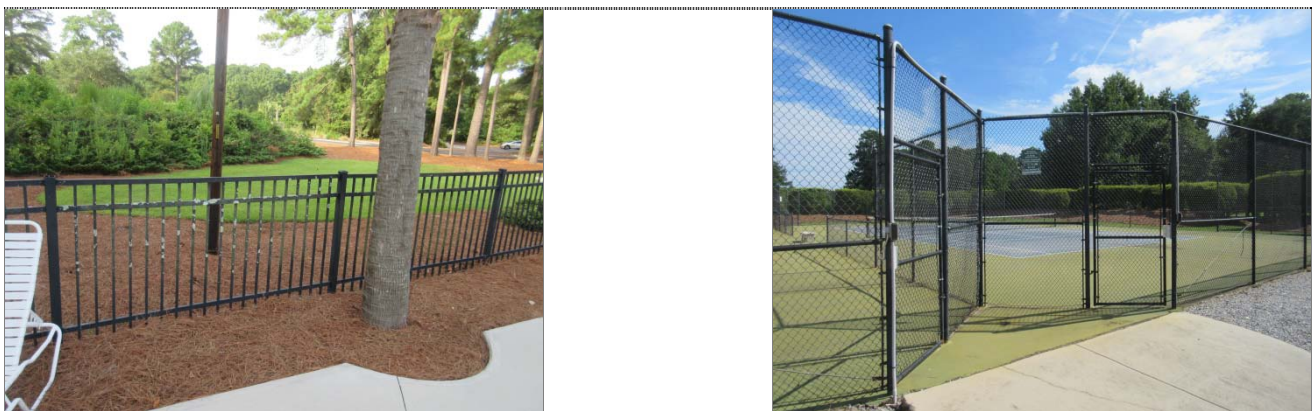
Fencing. The Association maintains metal fencing that is in generally fair condition. Fencing systems have a large number of configurations and finishes that can usually be repaired as a maintenance activity by replacing individual components as they become damaged or weathered.

Protection from string machine damage during lawn maintenance can extend the useful life of some fence types. Protection from this type of damage is typically provided by applying herbicides around post bases or installing protective sheathing.

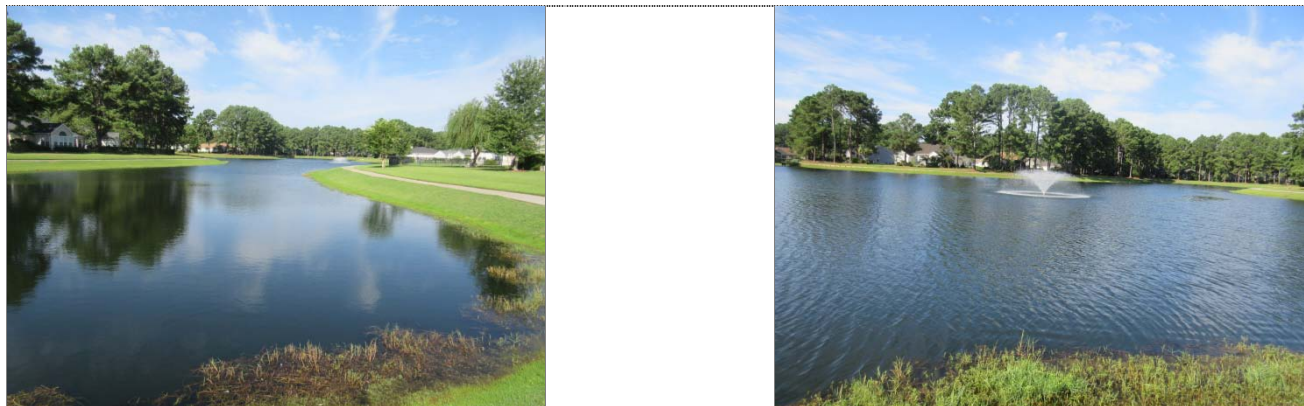
Storm Water Pond. The community is served by a storm water pond. Dredging is scheduled to be done on this pond in 2020.

Ponds will accumulate silt and over time and lose the ability to store storm water at design levels, which could result in overflows and minor local flooding. In addition, water quality can be negatively affected by increased siltation and debris accumulation. Accordingly, ponds require periodic dredging.

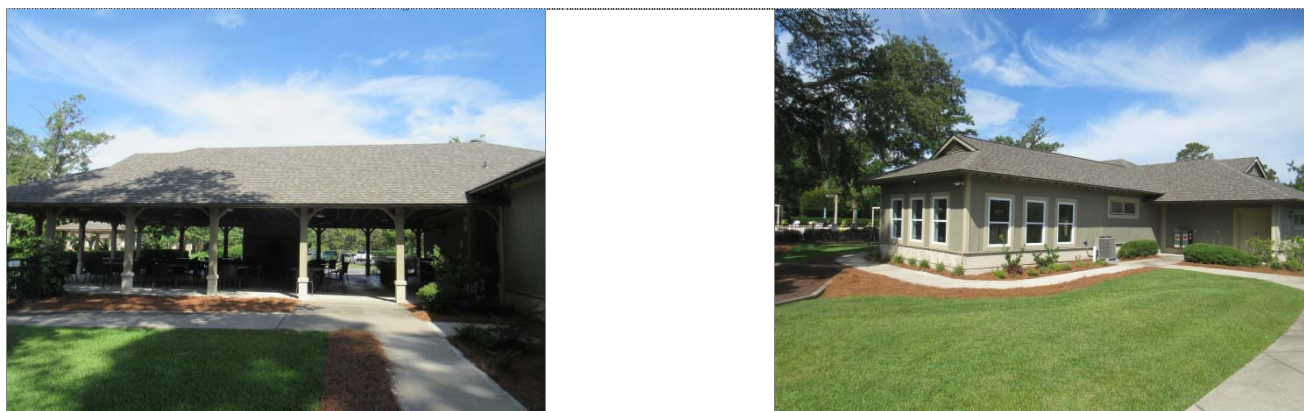
Building Roofing. The pavilion is roofed in asphalt shingles that are in generally excellent condition. The asphalt shingle roof was installed in 2018 when the fitness space was added.

Asphalt shingle roofs can have a useful life of 20 to 50 years depending on the weight and quality of the shingle. Weathered, curled, and missing shingles are all indications that the shingles may be nearing the end of their useful life.

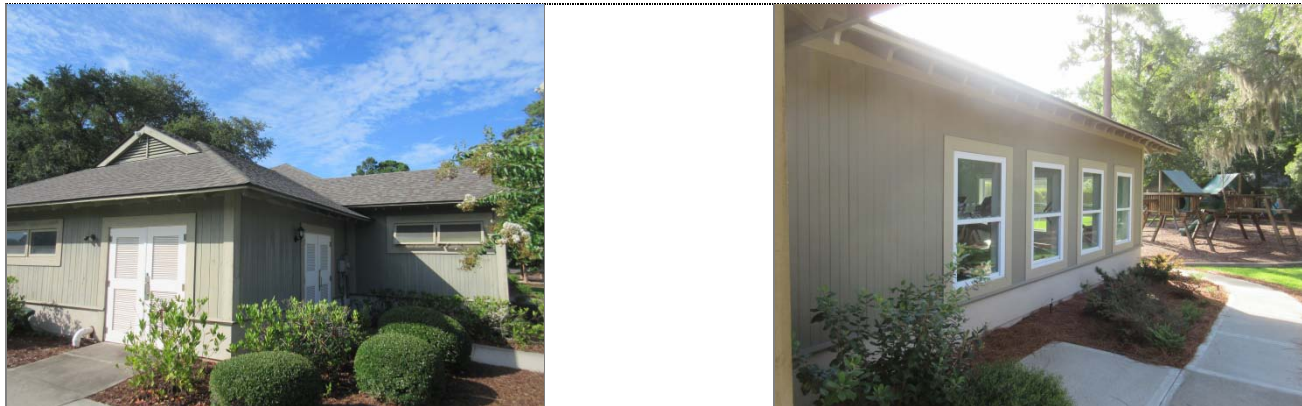
Stucco finishes are installed at the base of the enclosed pavilion's exterior. Most stucco deterioration is the result of water infiltration. This is generally first evident near the roof and around chimneys, windows, doors,

and other wall penetrations. Moisture can also gain access through materials that are in contact with ground by a process called wicking. Moisture will cause the supporting lath for the stucco to rot or corrode, resulting in the stucco pulling away from the substrate. Significant deterioration of wooden and metal structural elements can occur. Similar to Exterior Insulation Finishing Systems (EIFS) a "water-managed system" is the approach for new construction. However, many older installations assume a water barrier system. It is recommended for all stucco surfaces be inspected at least once each year.

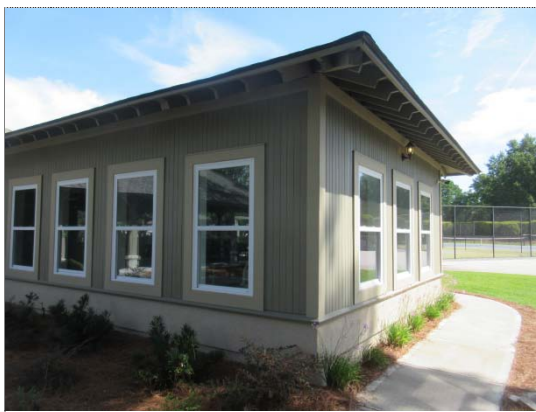
Windows and Doors. The Association is responsible for all of the windows and exterior doors of the facility.

The windows and doors are in generally good condition.

In general, we recommend coordinating the replacement of these units with other exterior work, such as siding and roof replacements. The weather tightness of the building envelope often requires transitional flashing and caulking that should be performed in coordination with each other. Warranties and advantages in 'economy of scale' can often result in lower overall replacement costs and results that are more reliable. Lastly, coordinated replacements offer the opportunity to correct initial construction defects and improve the effectiveness of details with improved construction techniques and materials.

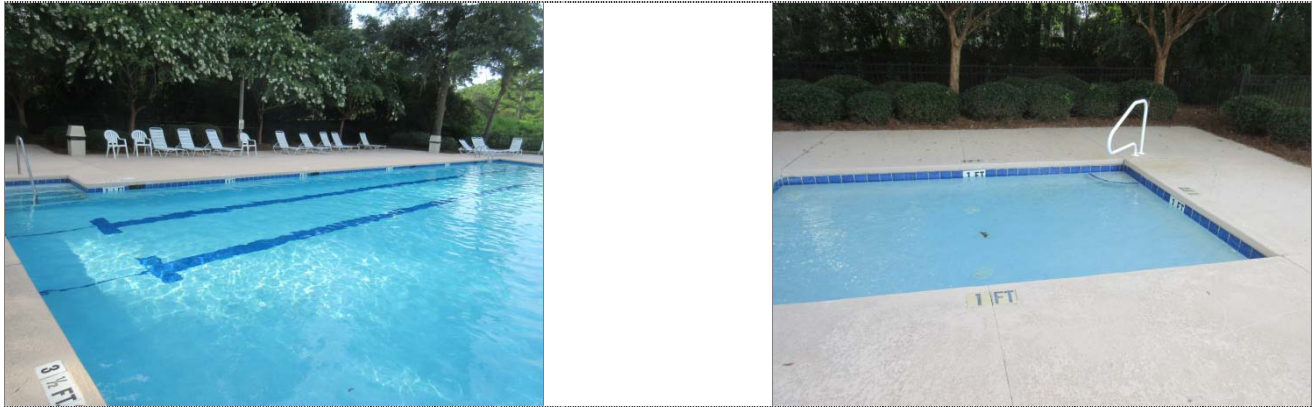
Swimming Pool. The community operates an outdoor pool and wading pool of concrete construction. Listed below are the major components of the pool facilities:

- Pool Shell. The shell for the swimming pool is in good condition.
- Pool Deck. The pool has a concrete deck. The overall condition of the deck is fair condition with tripping hazards.
- Pool Deck Coating. The concrete pool deck is coated with an elastomeric coating. The coating is in fair condition. We have assumed a service life for the coating of ten years.
- Whitecoat. The pool whitecoat is in good condition. We have assumed a service life of eight to ten years for the pool whitecoat.
- Waterline Tile. The waterline tile is in good condition. We have assumed that the waterline tile will be replaced or restored when the pool is whitecoated.
- Pump and Filter System. The pump and filter system components are in fair operating condition.
- Pool Fence. The swimming pool is enclosed by a metal fence that is in fair condition.

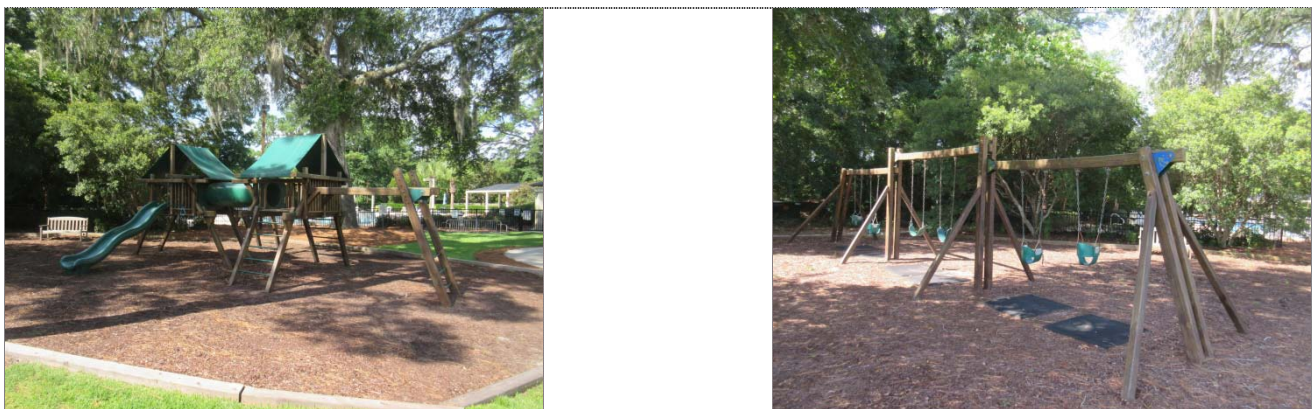
Tot Lots. The community maintains a tot lot. The tot lot includes play structures, miscellaneous play equipment, wood/synthetic borders, and a wood chip surface. The facility facilities are in generally good condition.

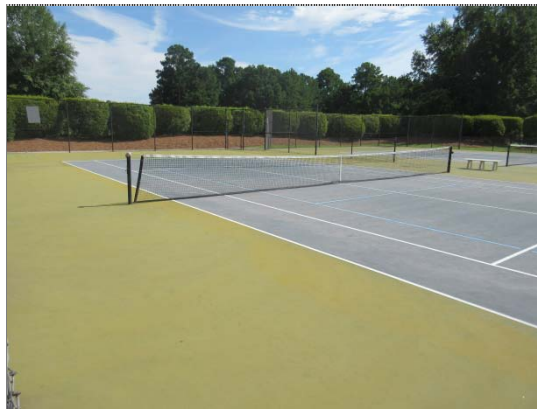
Tennis Courts. The community maintains two tennis courts. The overall condition of these courts is good.

- Asphalt Pavement (base layer). We have assumed a service life of 20 to 30 years for the asphalt base layer.
- Color Coat (surface layer). Annual cleaning is recommended to maintain the surface of the court. The base of a tennis court is subject to cracking and low spots known as "birdbaths" that can occur from weather and earth movement. A program to address cracks as they appear will help to prolong the useful life of the color coat. We have assumed a service life of five to ten years for the color coat.
